Debris/Ice/TPS Assessment and Integrated Photographic Analysis of Shuttle Mission STS-94

**DEBRIS/ICE/TPS ASSESSMENT
AND
INTEGRATED PHOTOGRAPHIC ANALYSIS
OF
SHUTTLE MISSION STS-94**

1 July 1997

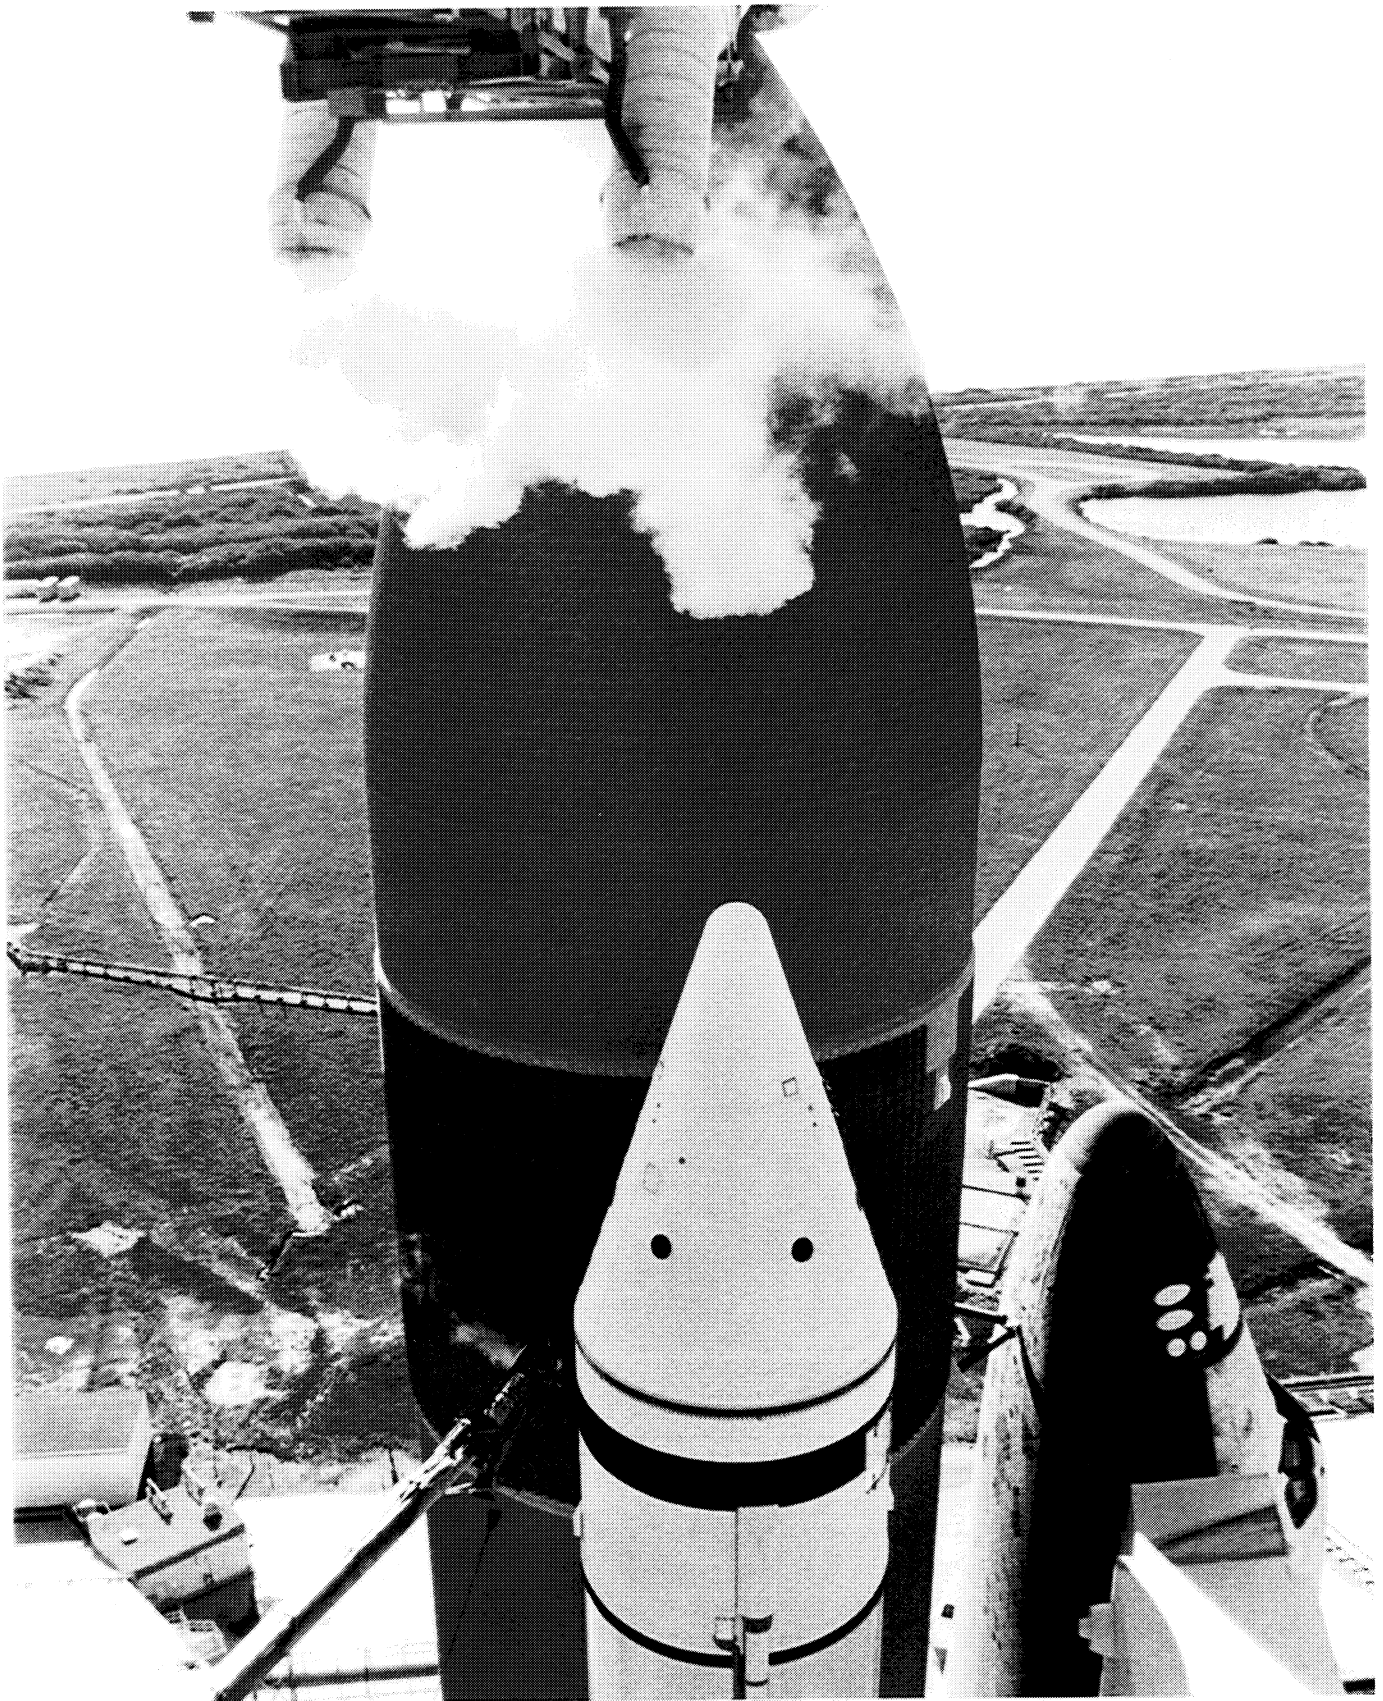
Photo 3: LO2 Tank and Intertank After Cryoload

The Final Inspection Team observed light condensate, but no ice or frost accumulations, on the LO2 tank acreage. TPS surface temperatures averaged 70 degrees F.

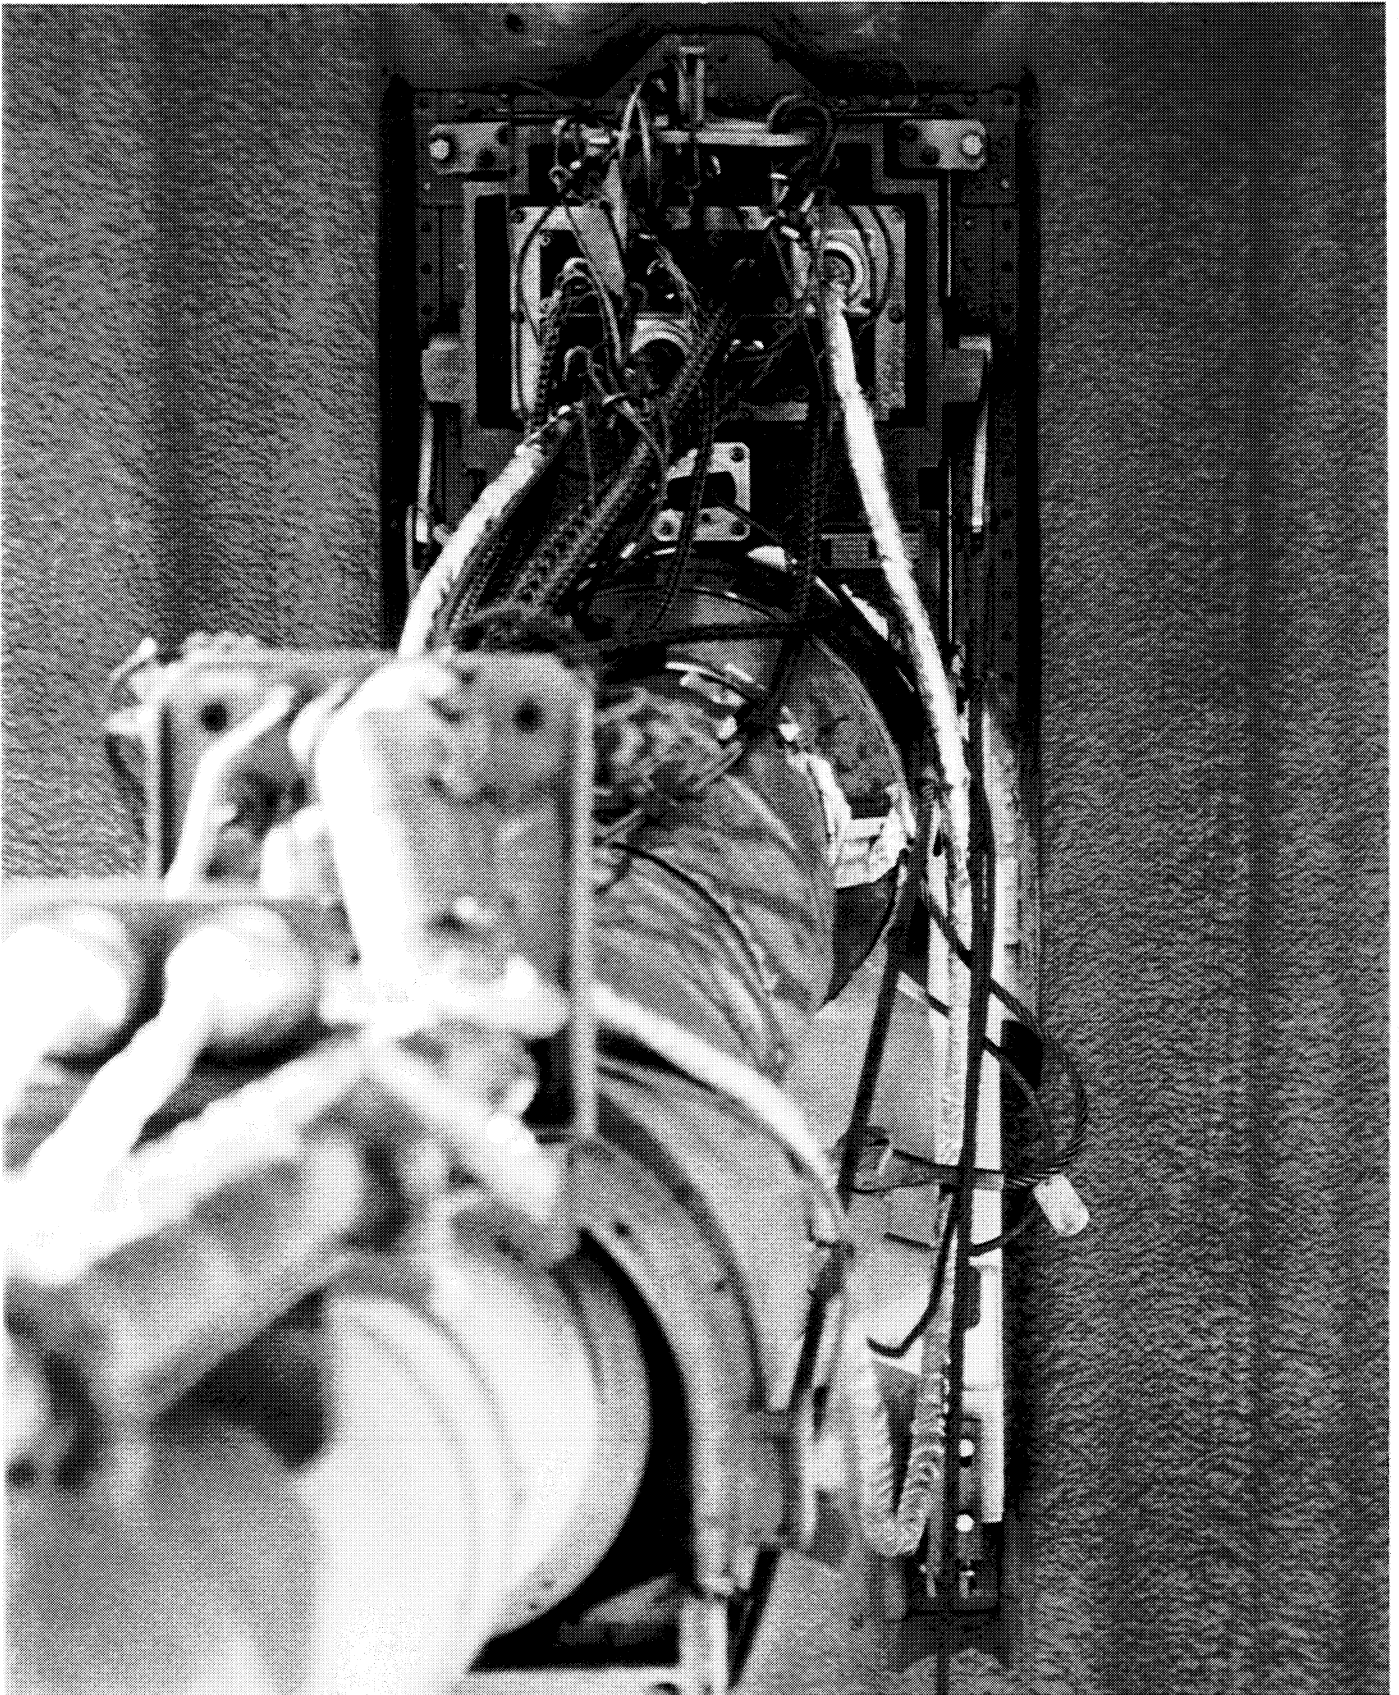
Photo 4: GUCP

Ice/frost accumulation on the GUCP appeared typical.

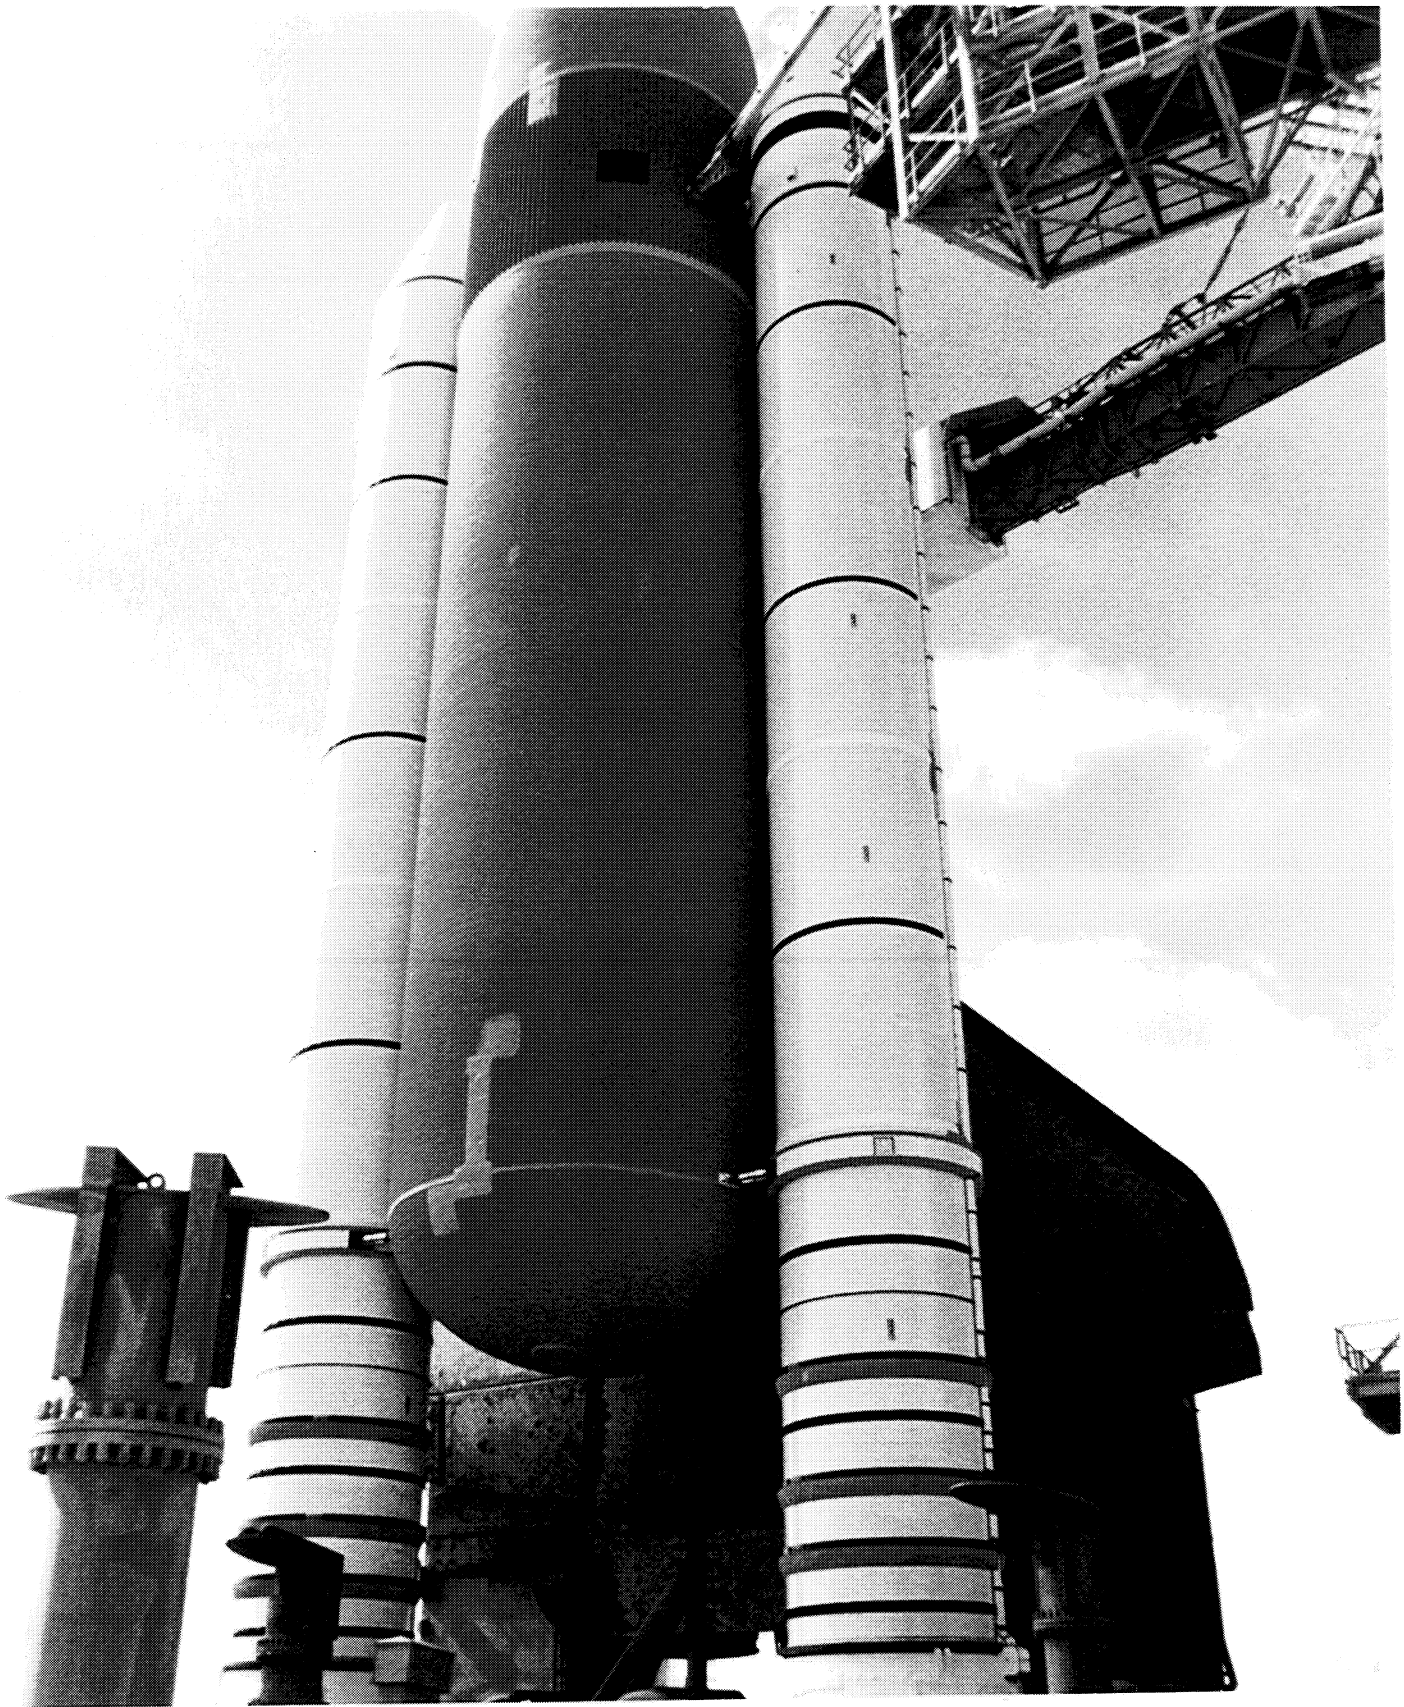
Photo 5: ET LH2 Tank Acreege

The Final Inspection Team observed light condensate, but no ice or frost accumulations, on the LH2 tank acreege. TPS surface temperatures averaged 68 degrees F.

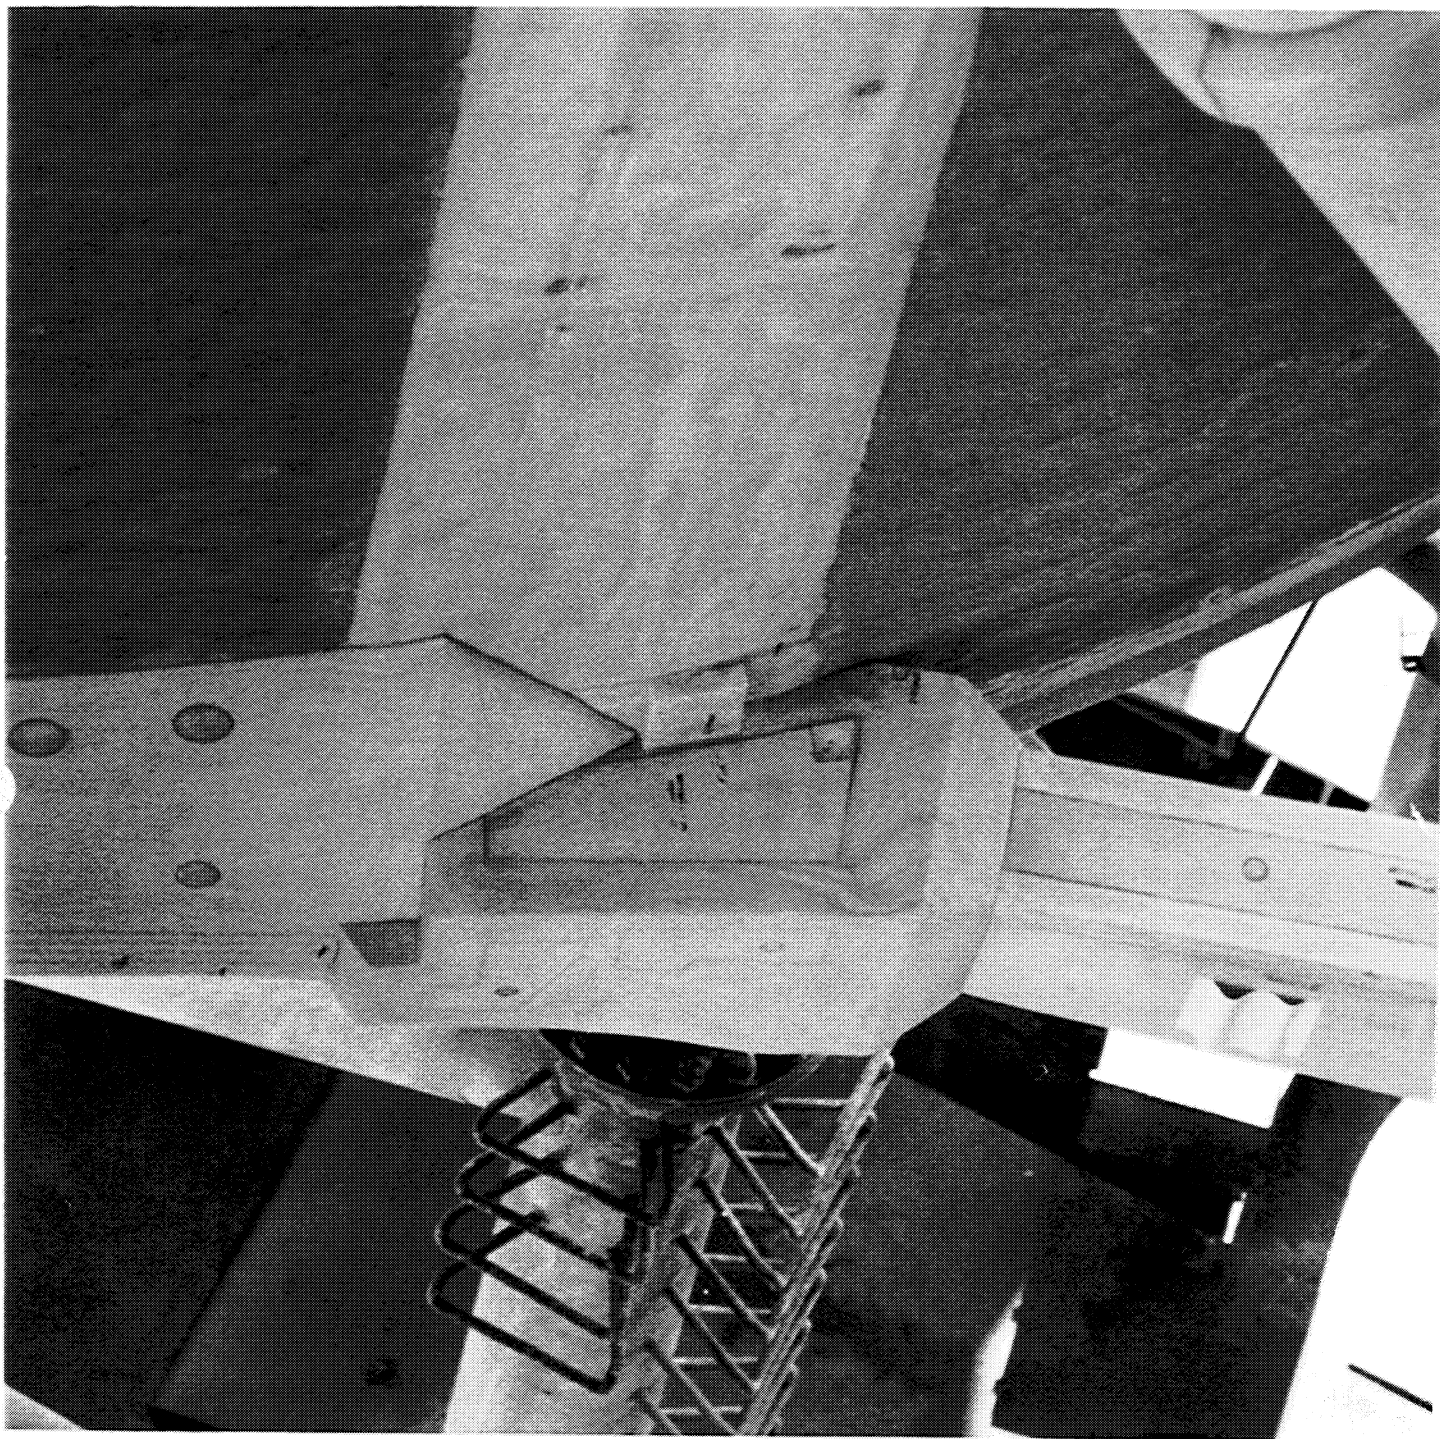
Photo 6: -Y Vertical Strut

No stress relief crack had formed on the -Y vertical strut forward facing TPS. The presence of a crack is expected and acceptable for flight per the NSTS-08383 criteria.

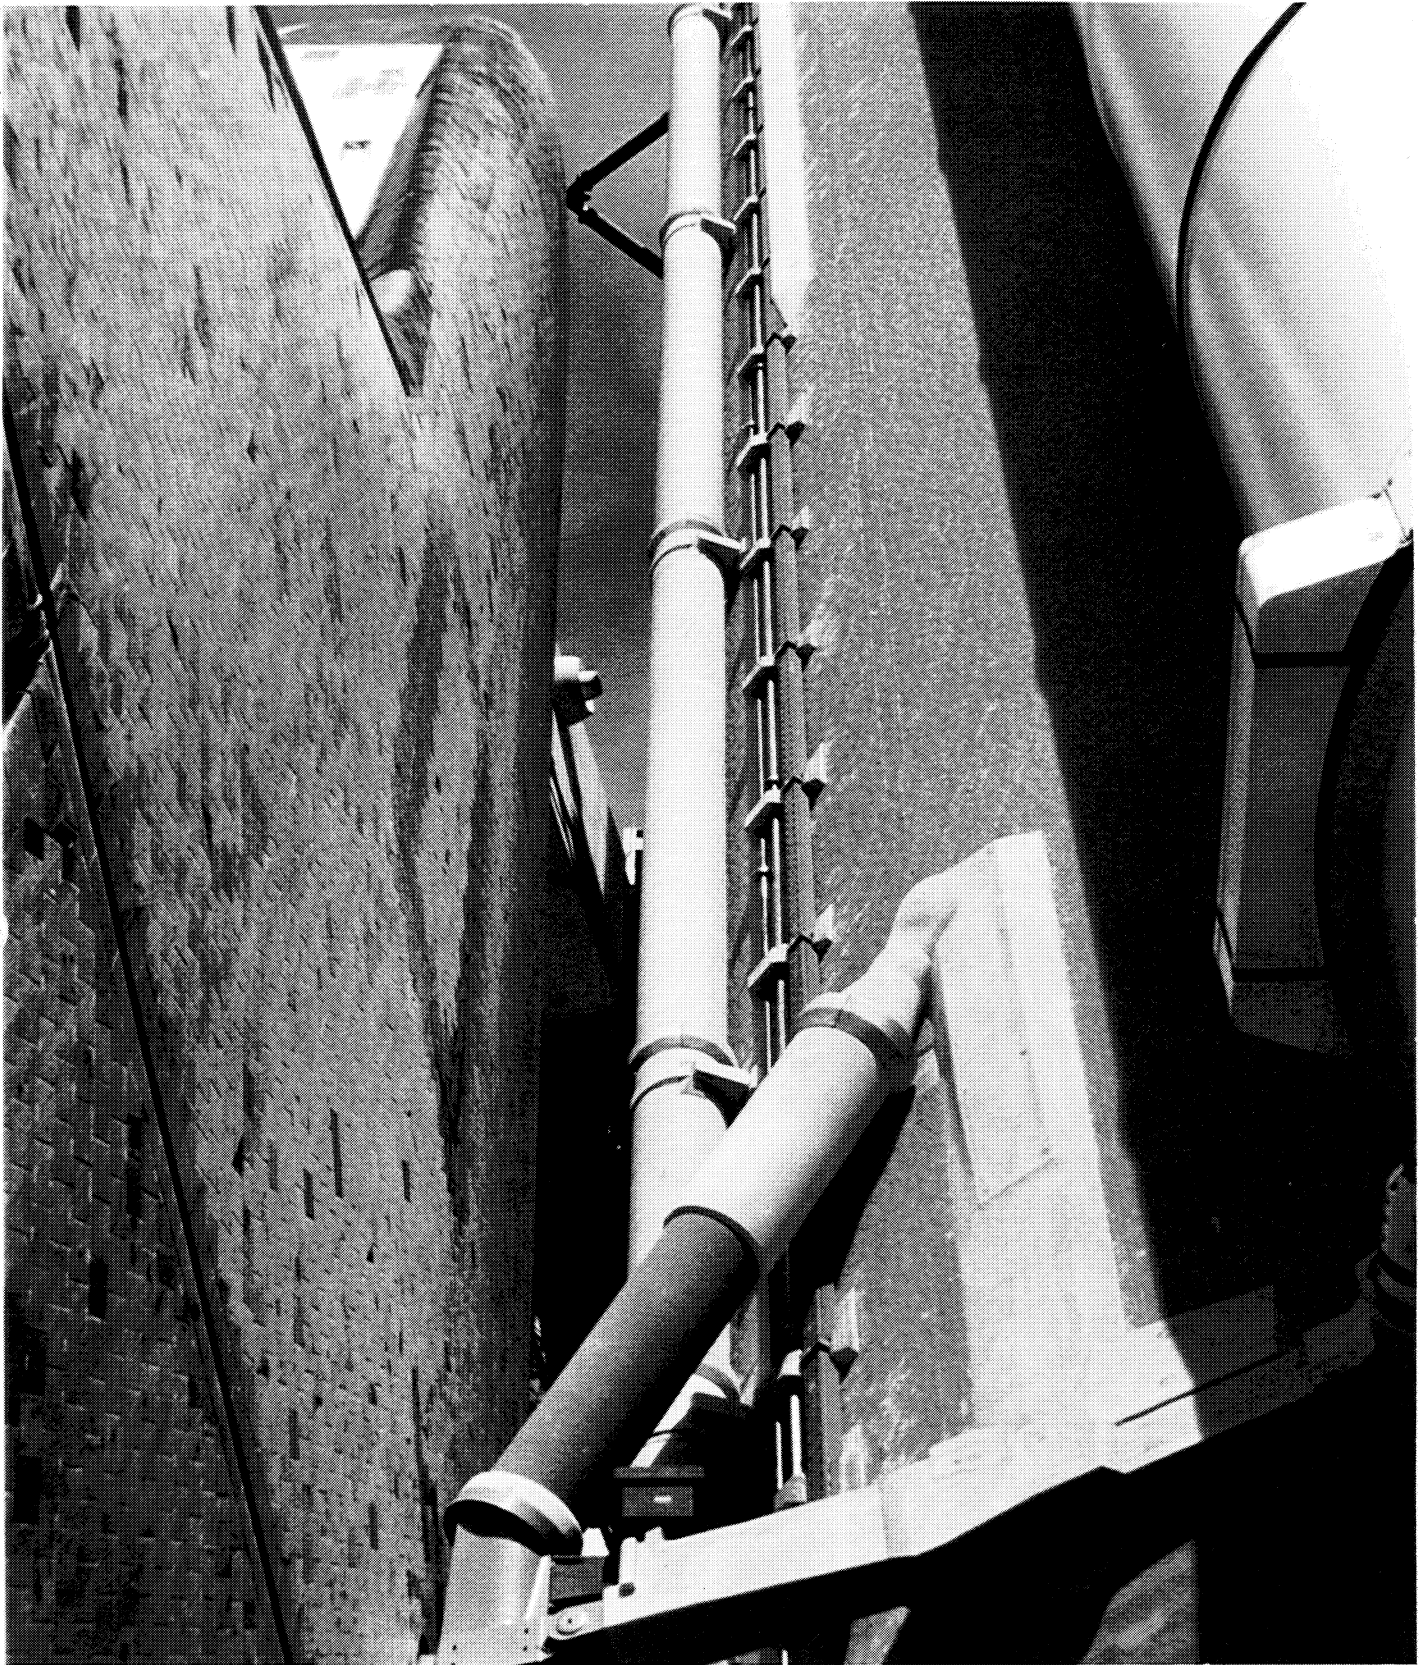
Photo 7: LH2 Feedline and +Z Side Repairs

The LH2 feedline bellows were wet with condensate. All TPS repairs on the +Z side of the LH2 tank were intact and in nominal condition.

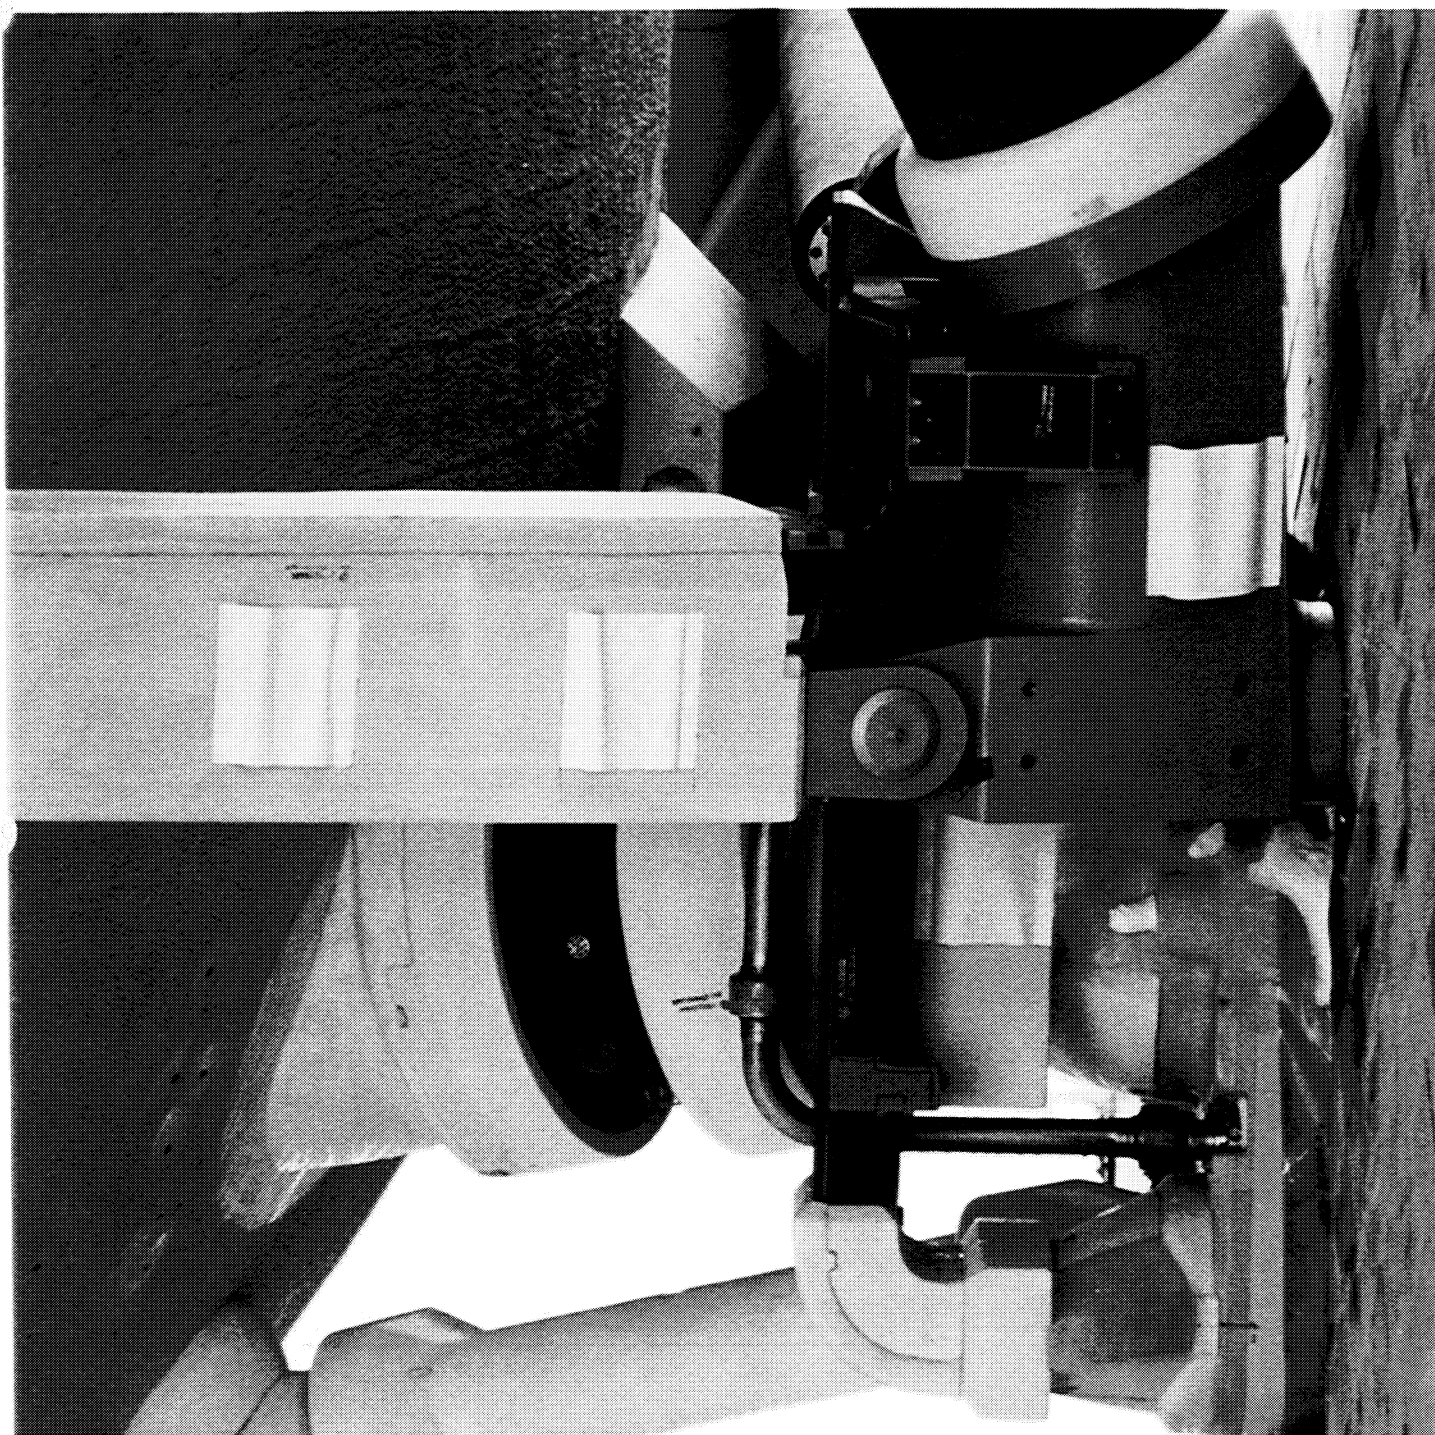
Photo 8: ET/Orbiter LH2 Umbilical

Typical amounts of ice/frost had accumulated on the LH2 ET/ORB umbilical purge barrier outboard side and forward surface. Smaller than usual ice/frost fingers were present on the pyro canister and plate gap purge vents.

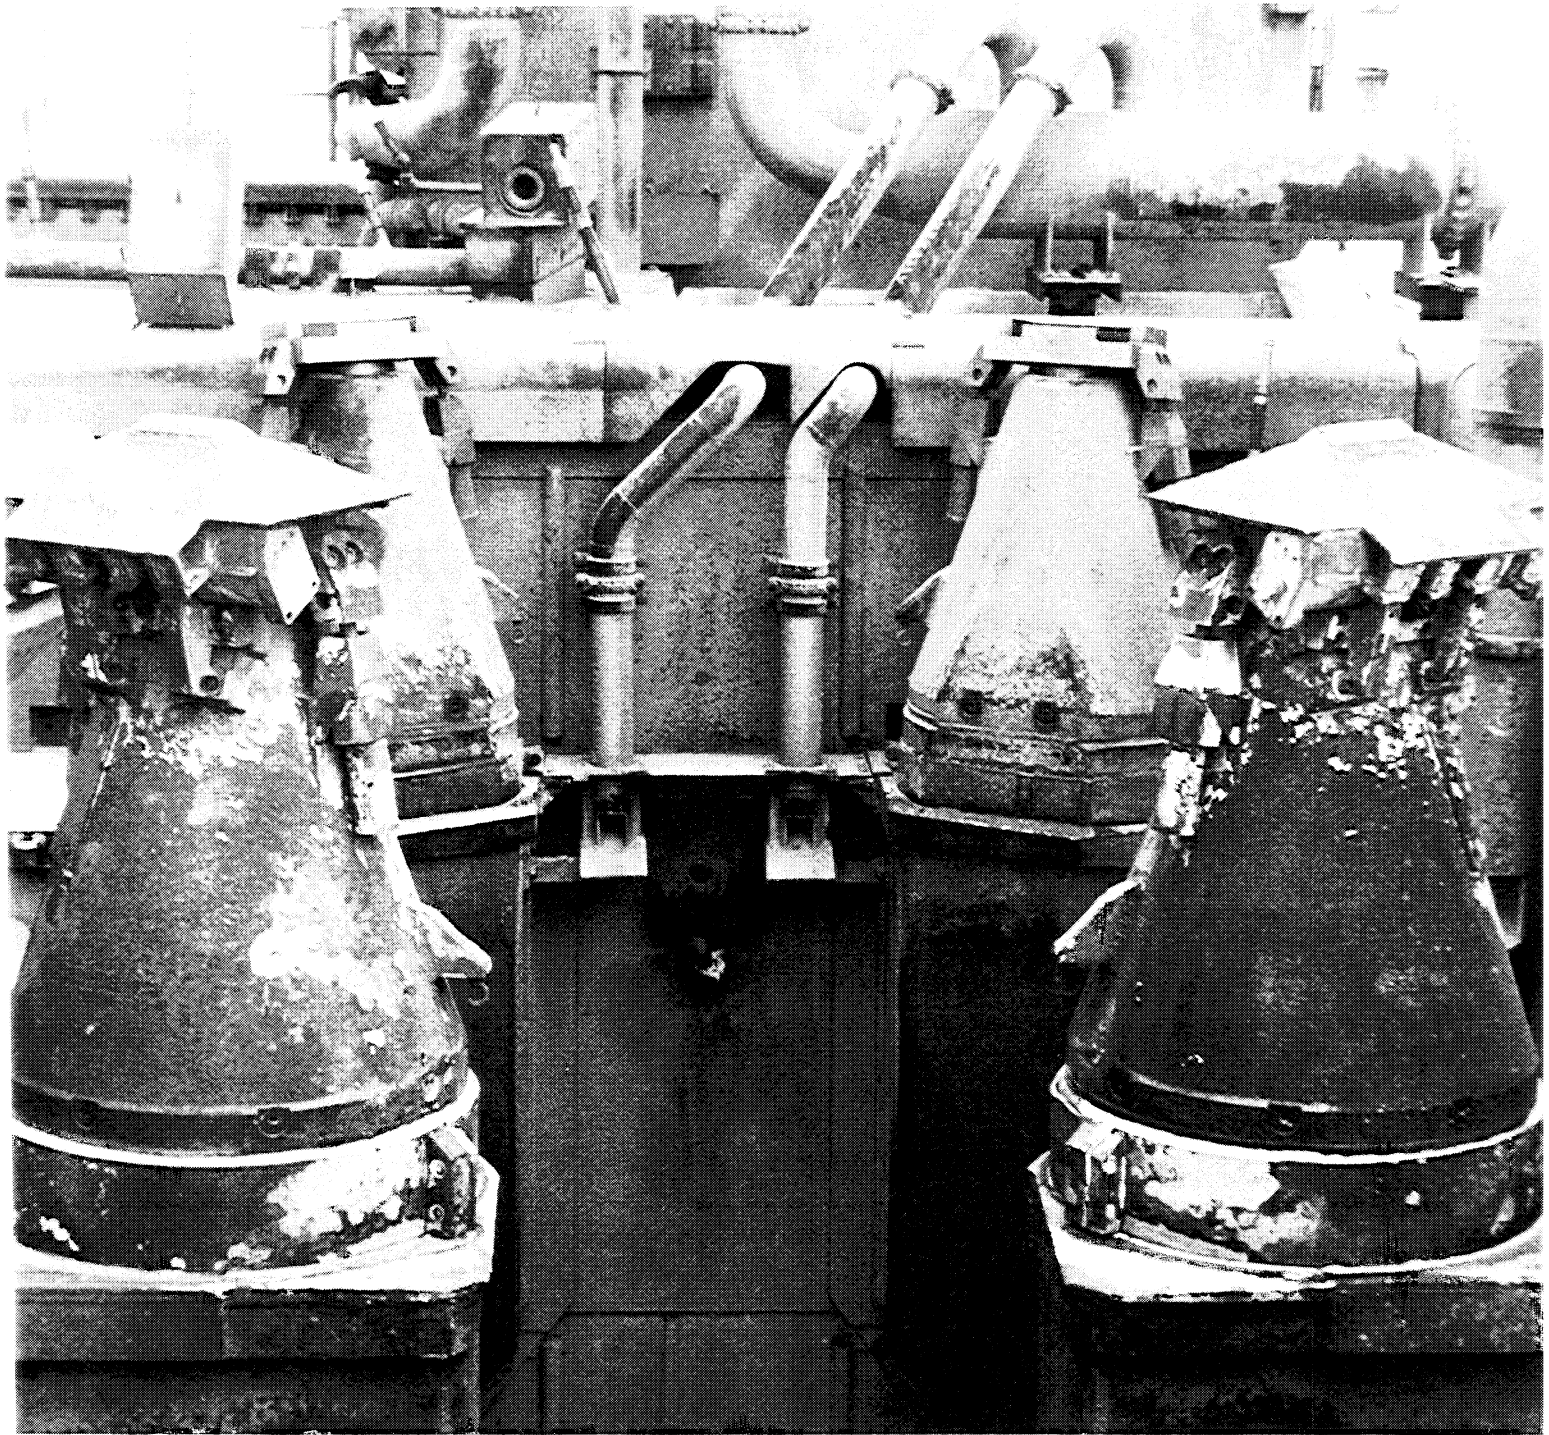
Photo 9: Holddown Post # 7 and #8
SRB Hold Down Post (HDP) erosion was typical.

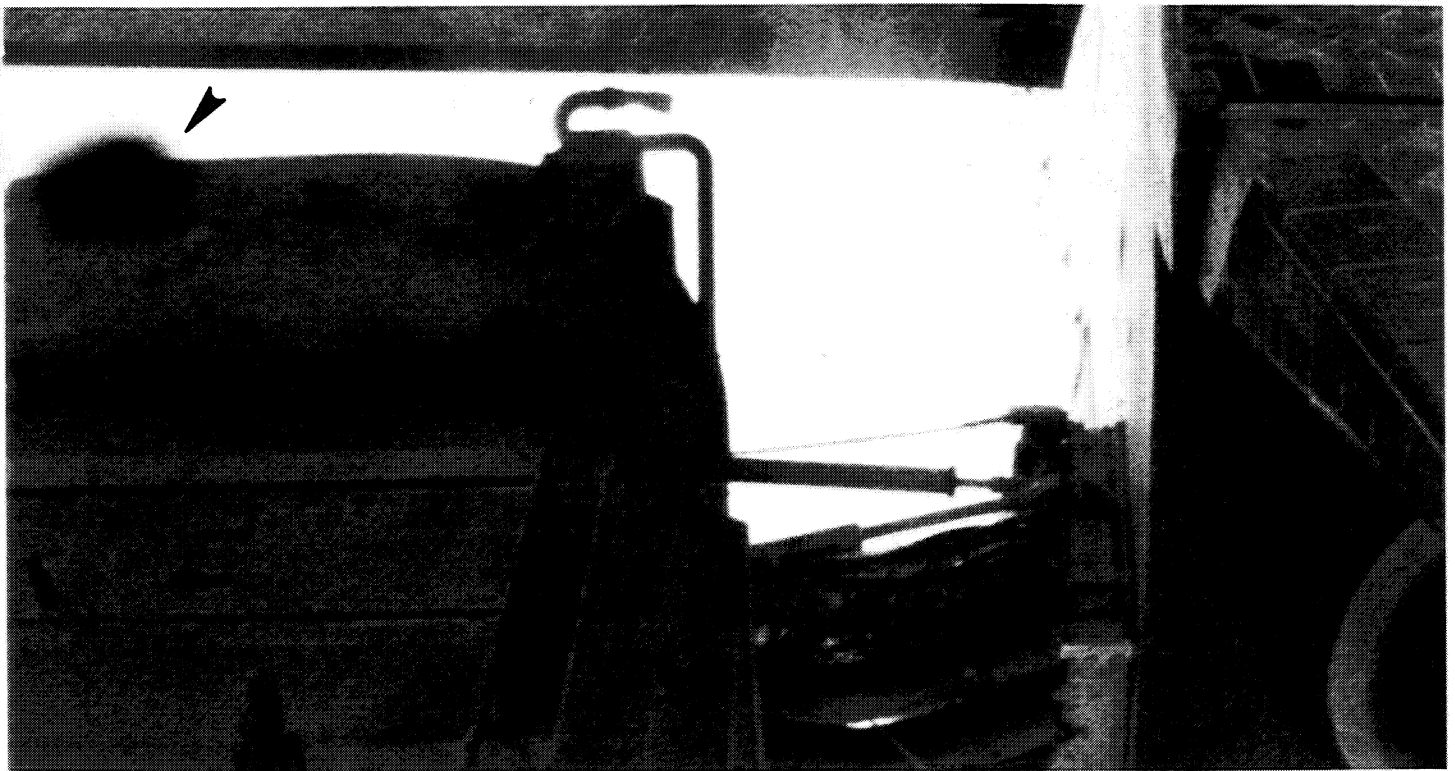
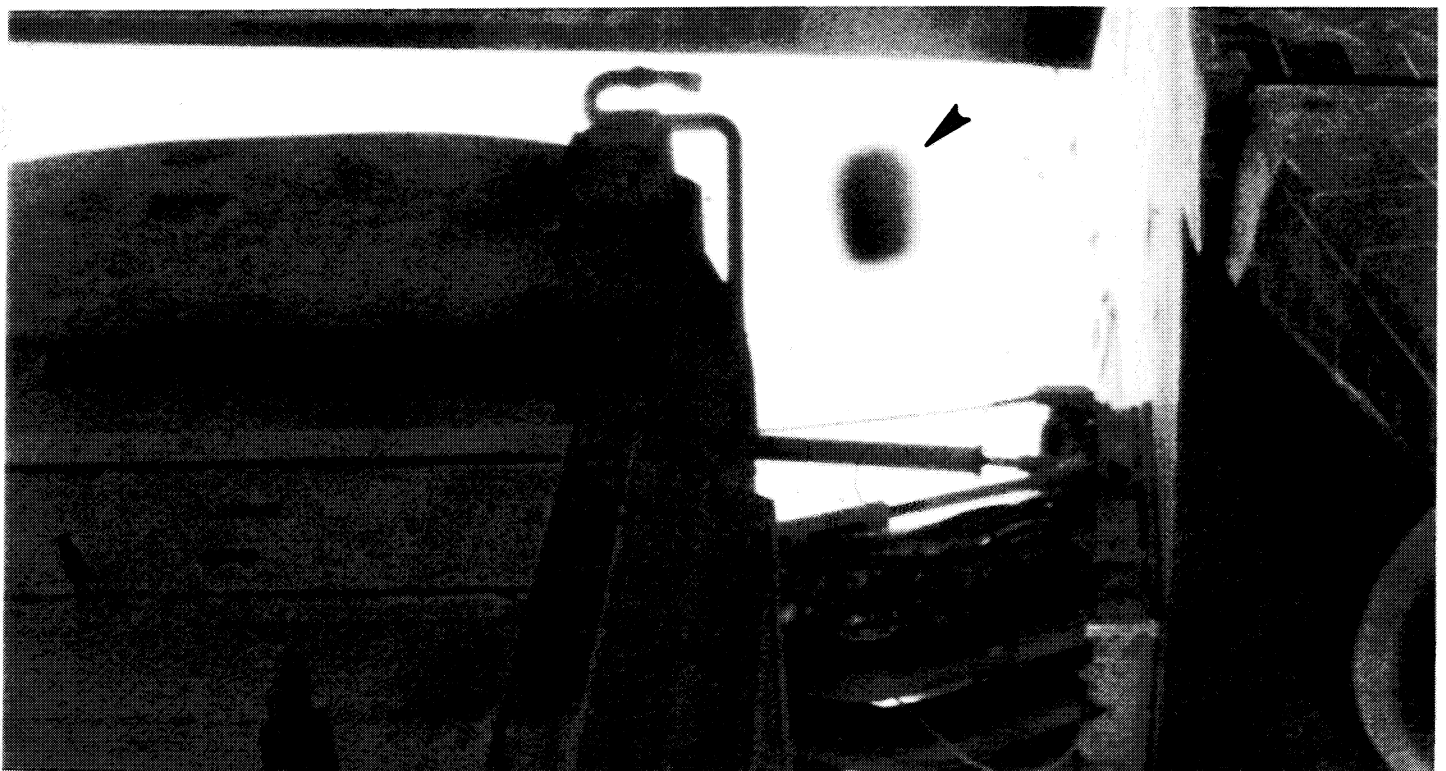
Photo 10: Debris Visible on -Z side of LO2 TSM

A dark colored object was visible on the -Z side of the LO2 TSM at 18:01:55.872 UTC. The object first appeared outboard of the right hand SRB and fell toward the base of the TSM. The object appeared to be close to the camera lens. The object did not impact the vehicle.

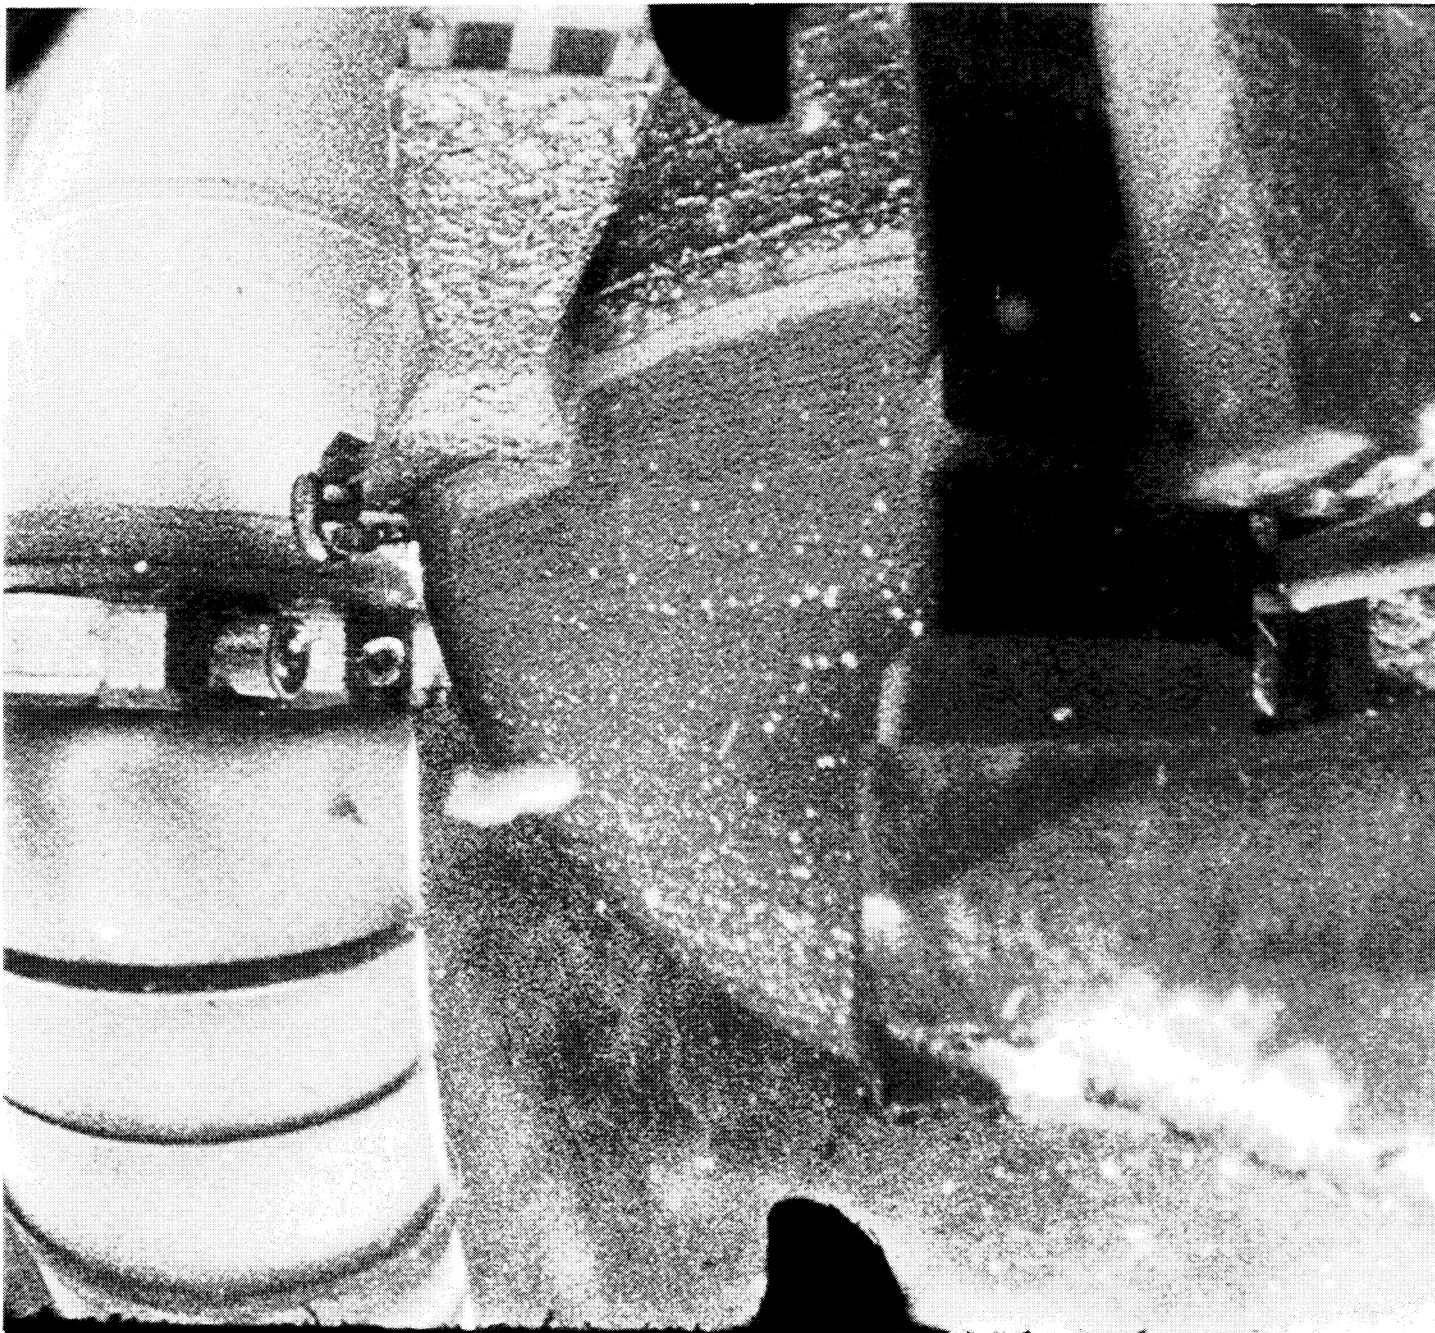
Photo 11 : SRB/ET Separation

SRB separation from the External Tank appeared nominal.

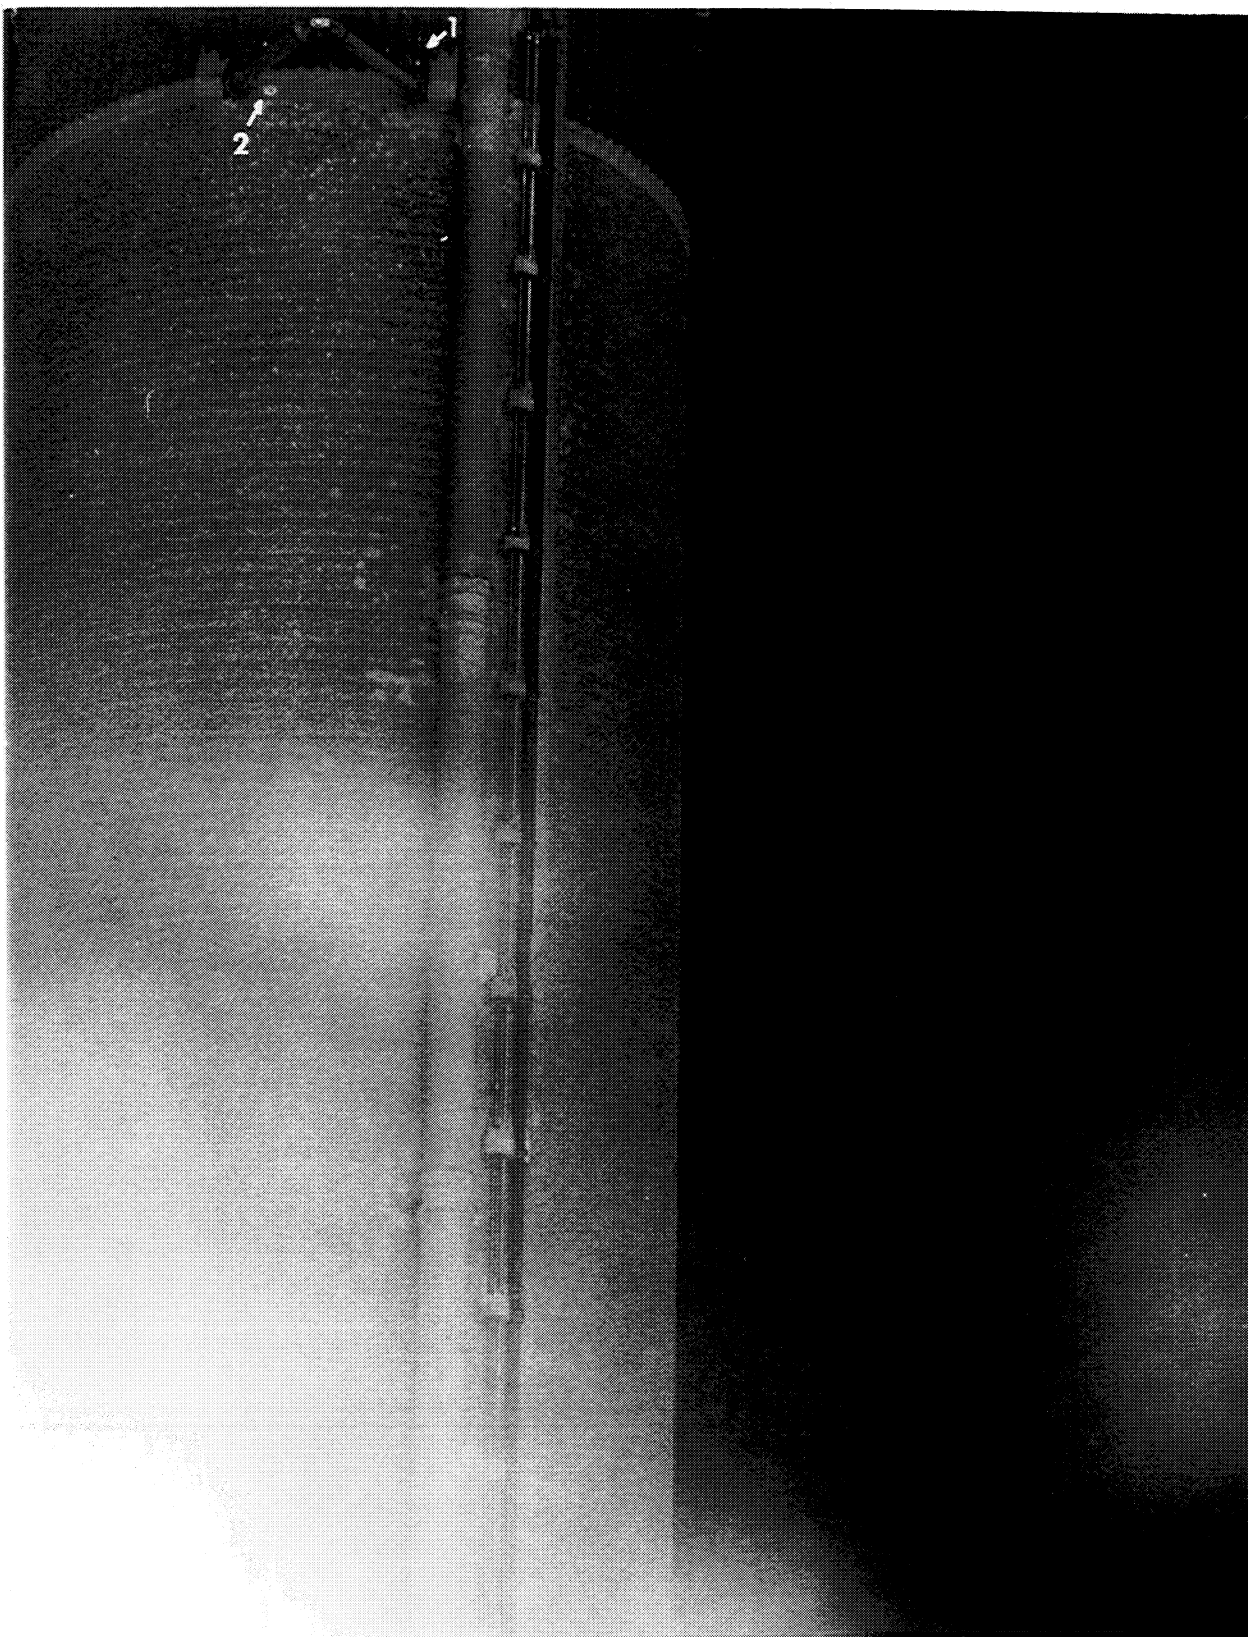
Photo 12 : ET Intertank TPS Divots

- (1) Seven very small TPS divots were detected on intertank stringer heads forward of the bipods.
- (2) A 6-inch by 6-inch area of foam was missing from the -Y bipod jack pad closeout with some primer showing in the deep part of the divot.
